Atwater Park Landscape Plan

ATWATER LANDSCAPE
EXISTING CONDITIONS
SNYDER & ASSOCIATES, INC.
 VILLAGE OF SHOREWOOD, WISCONSIN
 5010 VOGES ROAD
 MADISON, WISCONSIN 53718
 608-838-0444 | www.snyder-associates.com

VILLAGE OF SHOREWOOD : ATWATER PARK - SITE CIRCULATION UPDATES

SITE INVENTORY

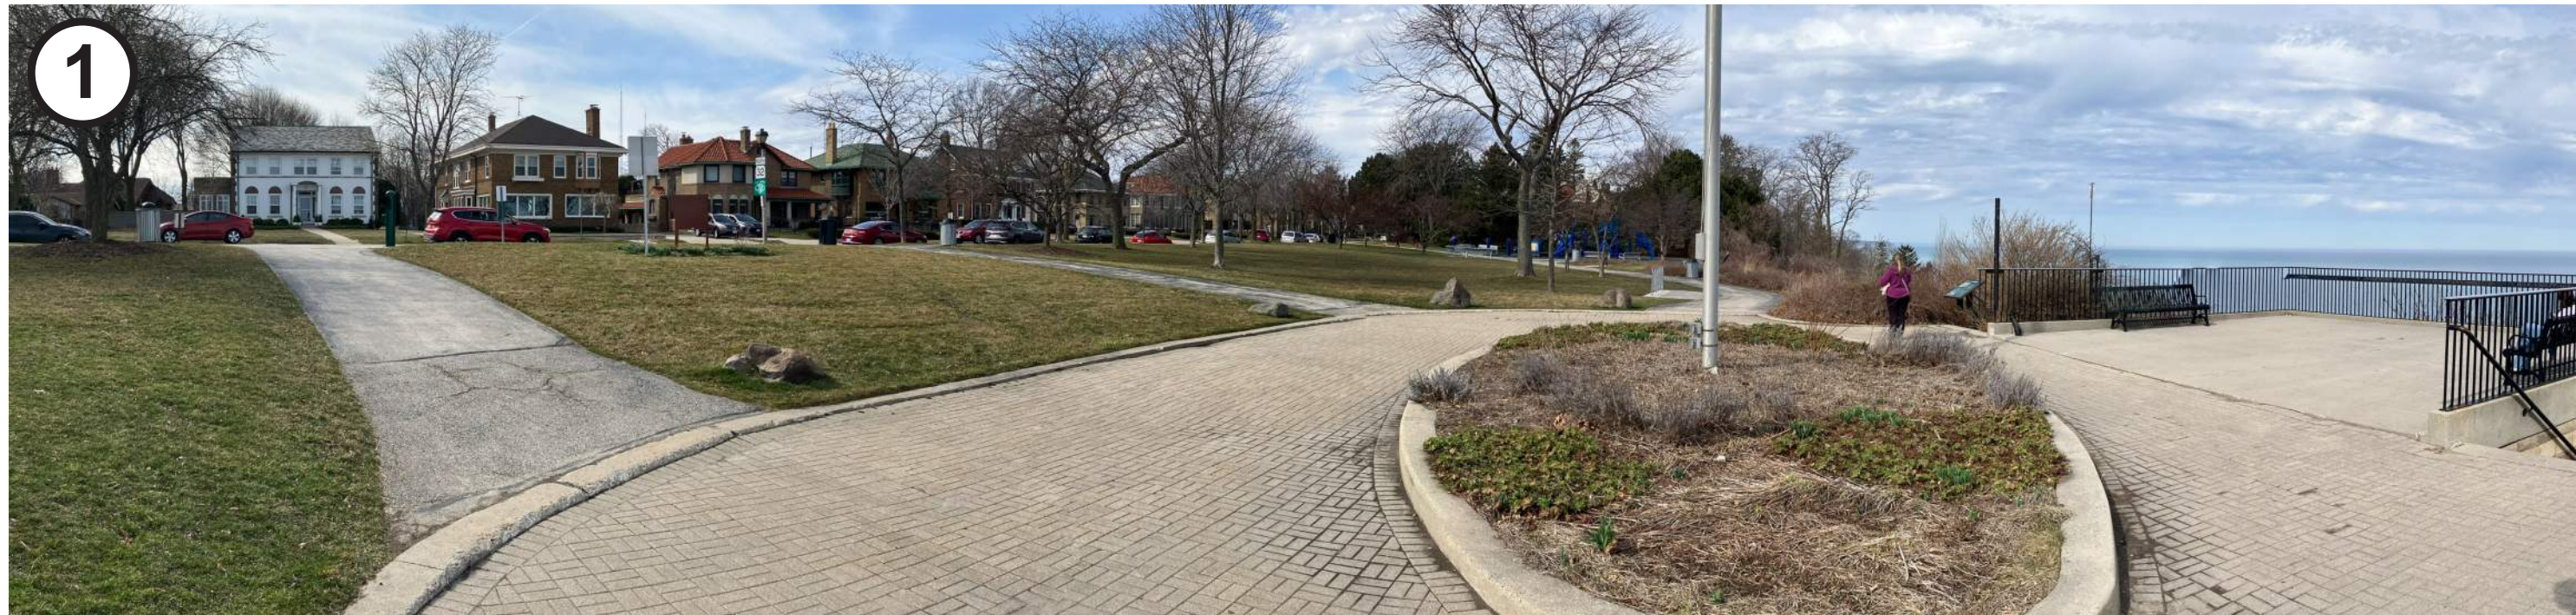
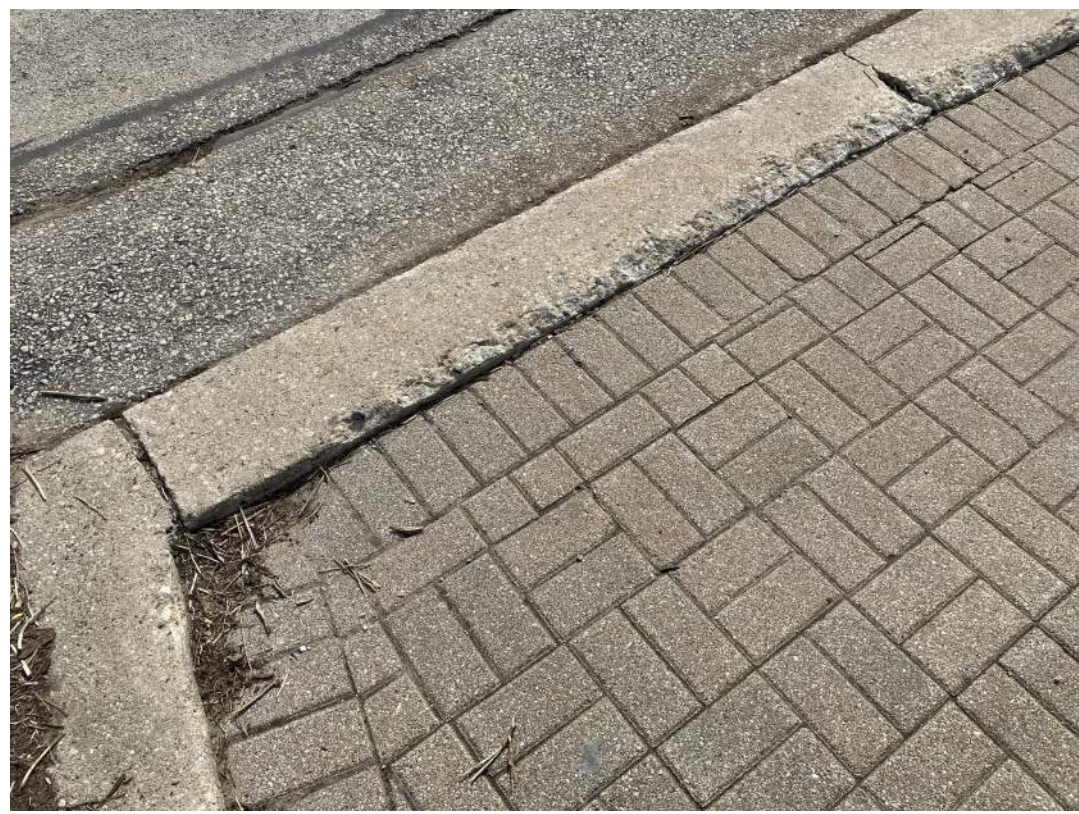
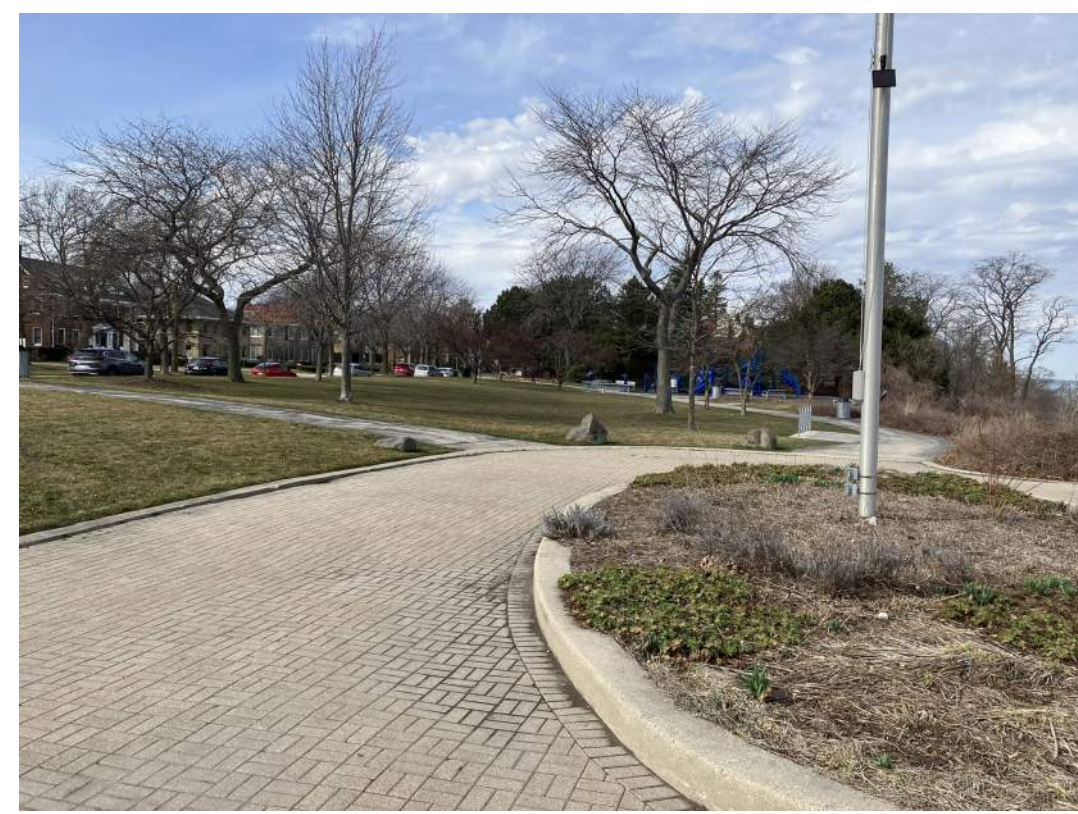
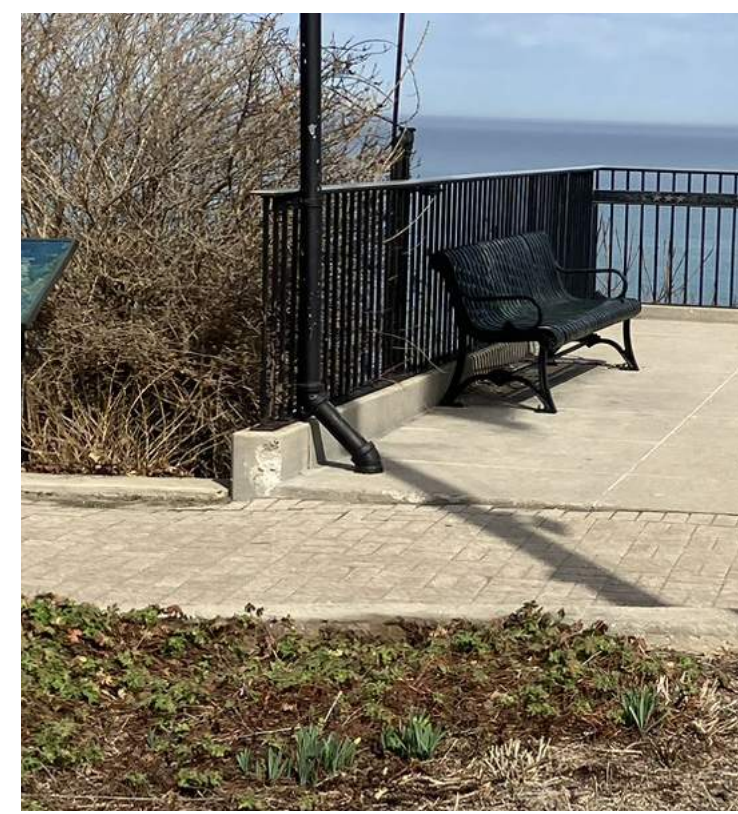
CENTRAL SPACE:

- Central planter limits mobility and the potential for larger events and maintenance circulation.
- Pavers have settled and created “ponding” and tripping issues.
- Mix of materials (pavers, concrete, and asphalt) creates challenges for level transitions between plaza and path.
- Flag pole requires bucket truck for raising and lowering.
- Plaza topography generally sheds water towards the roof of the restroom structure.

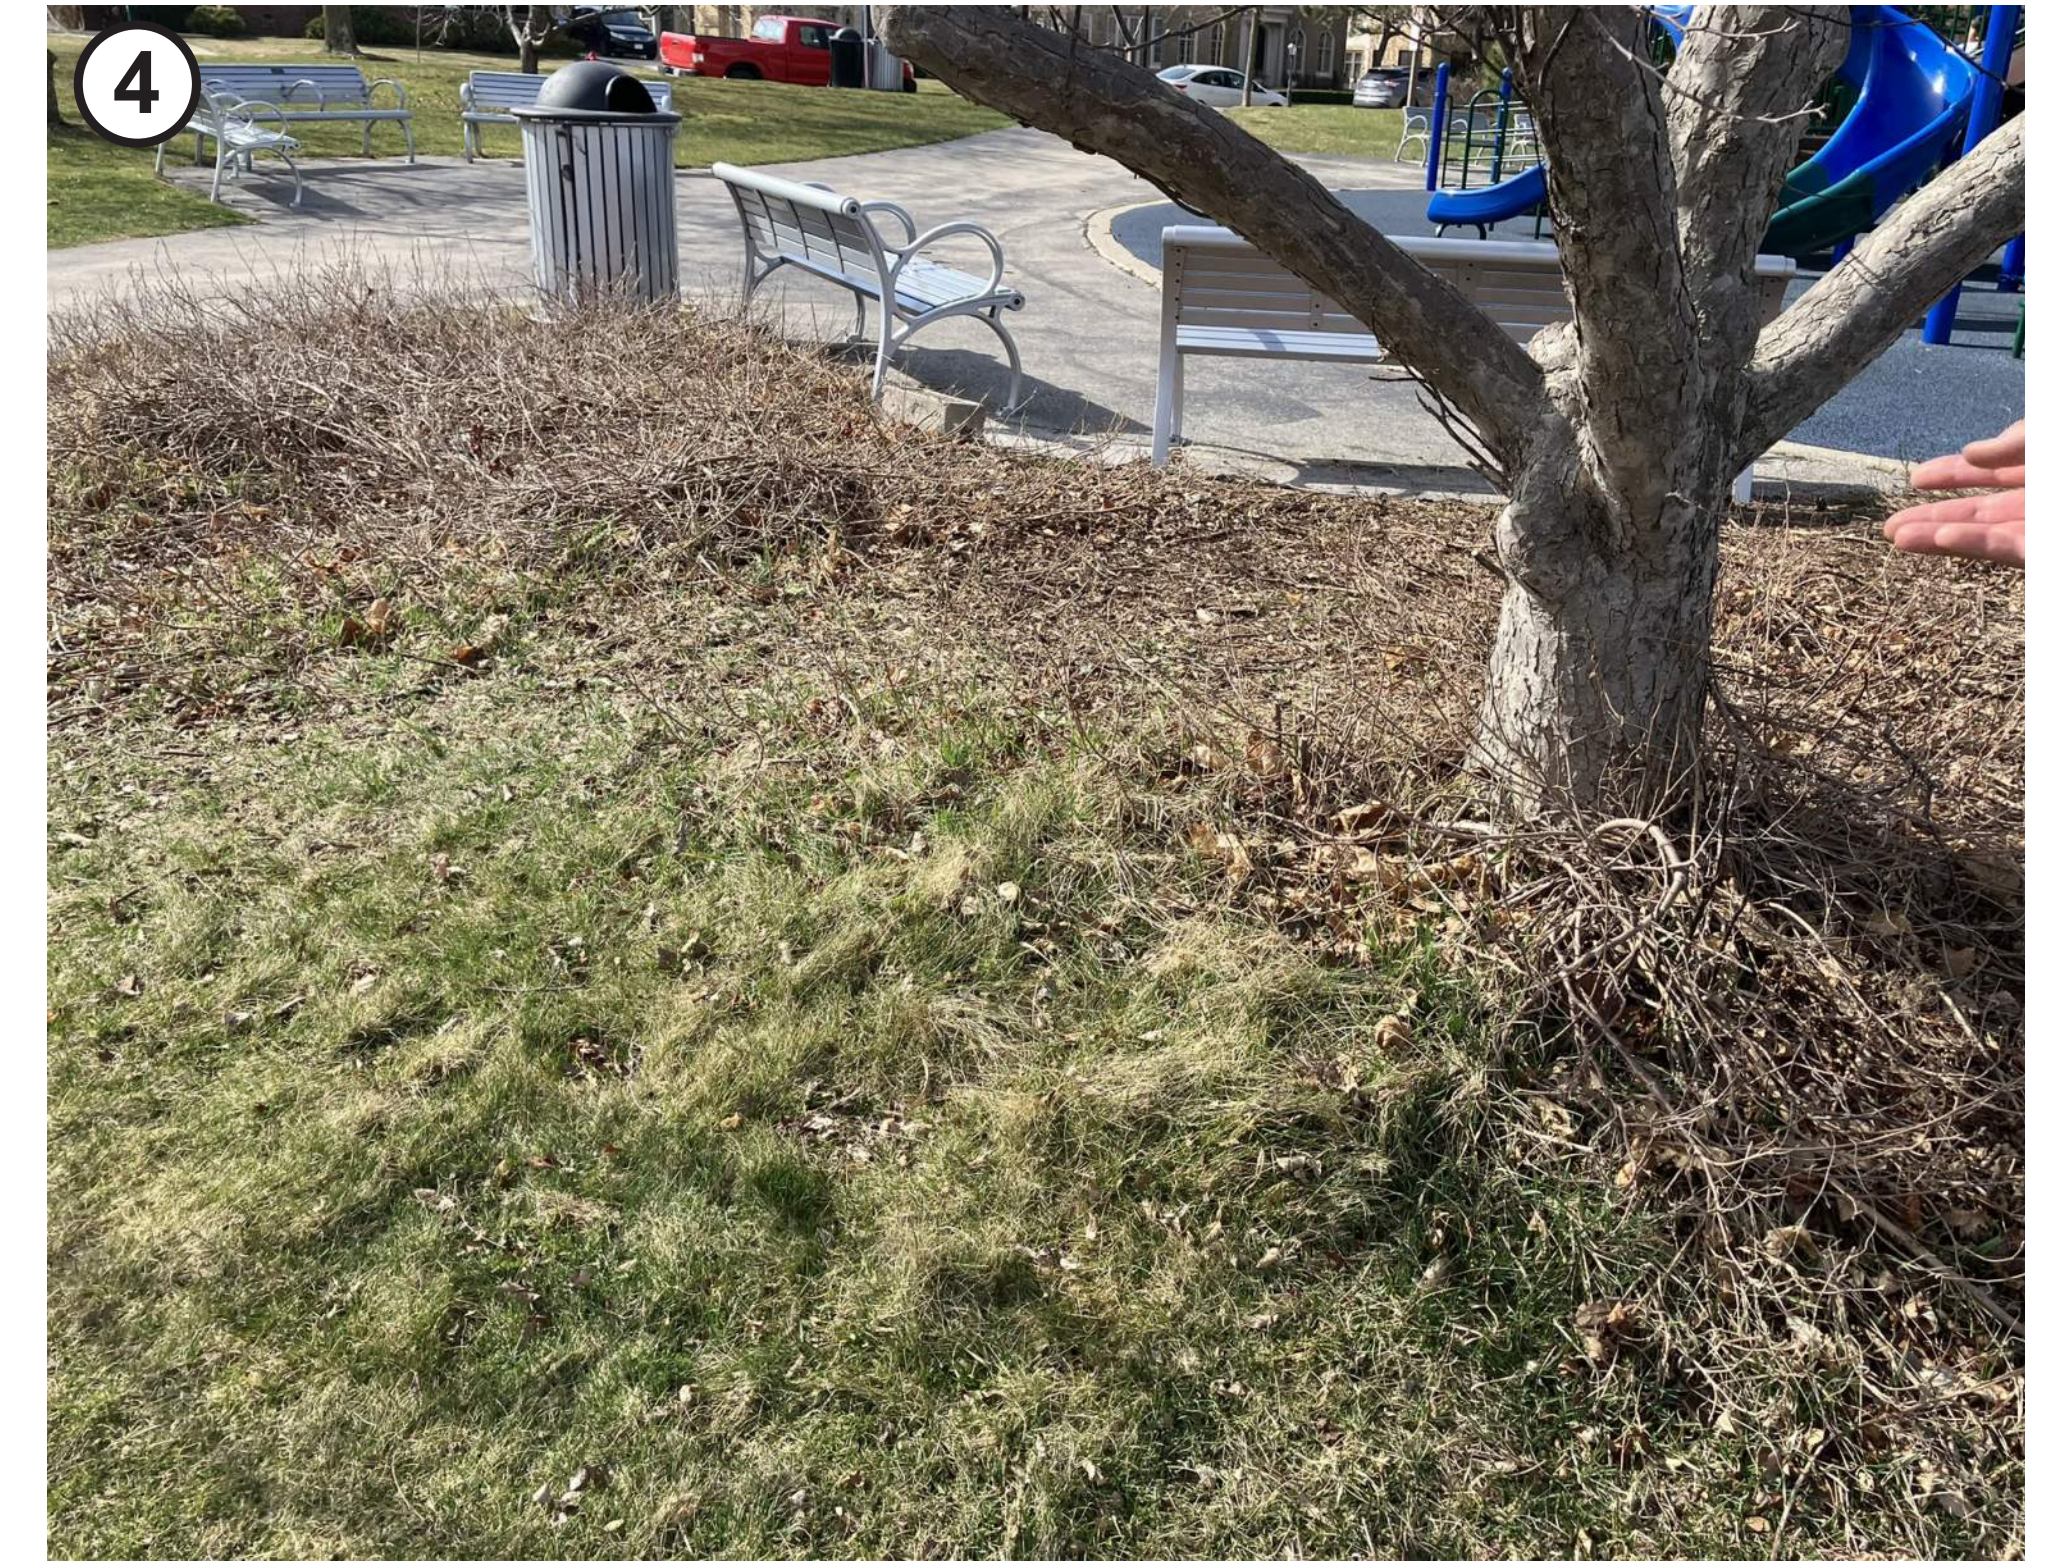
LIMITED VEGETATION GROWTH

- Turf has consumed some planter beds and limited enhanced landscape spaces.
- Foot traffic and heavy use has limited plant survivability at the *Spillover II* public art sculpture.

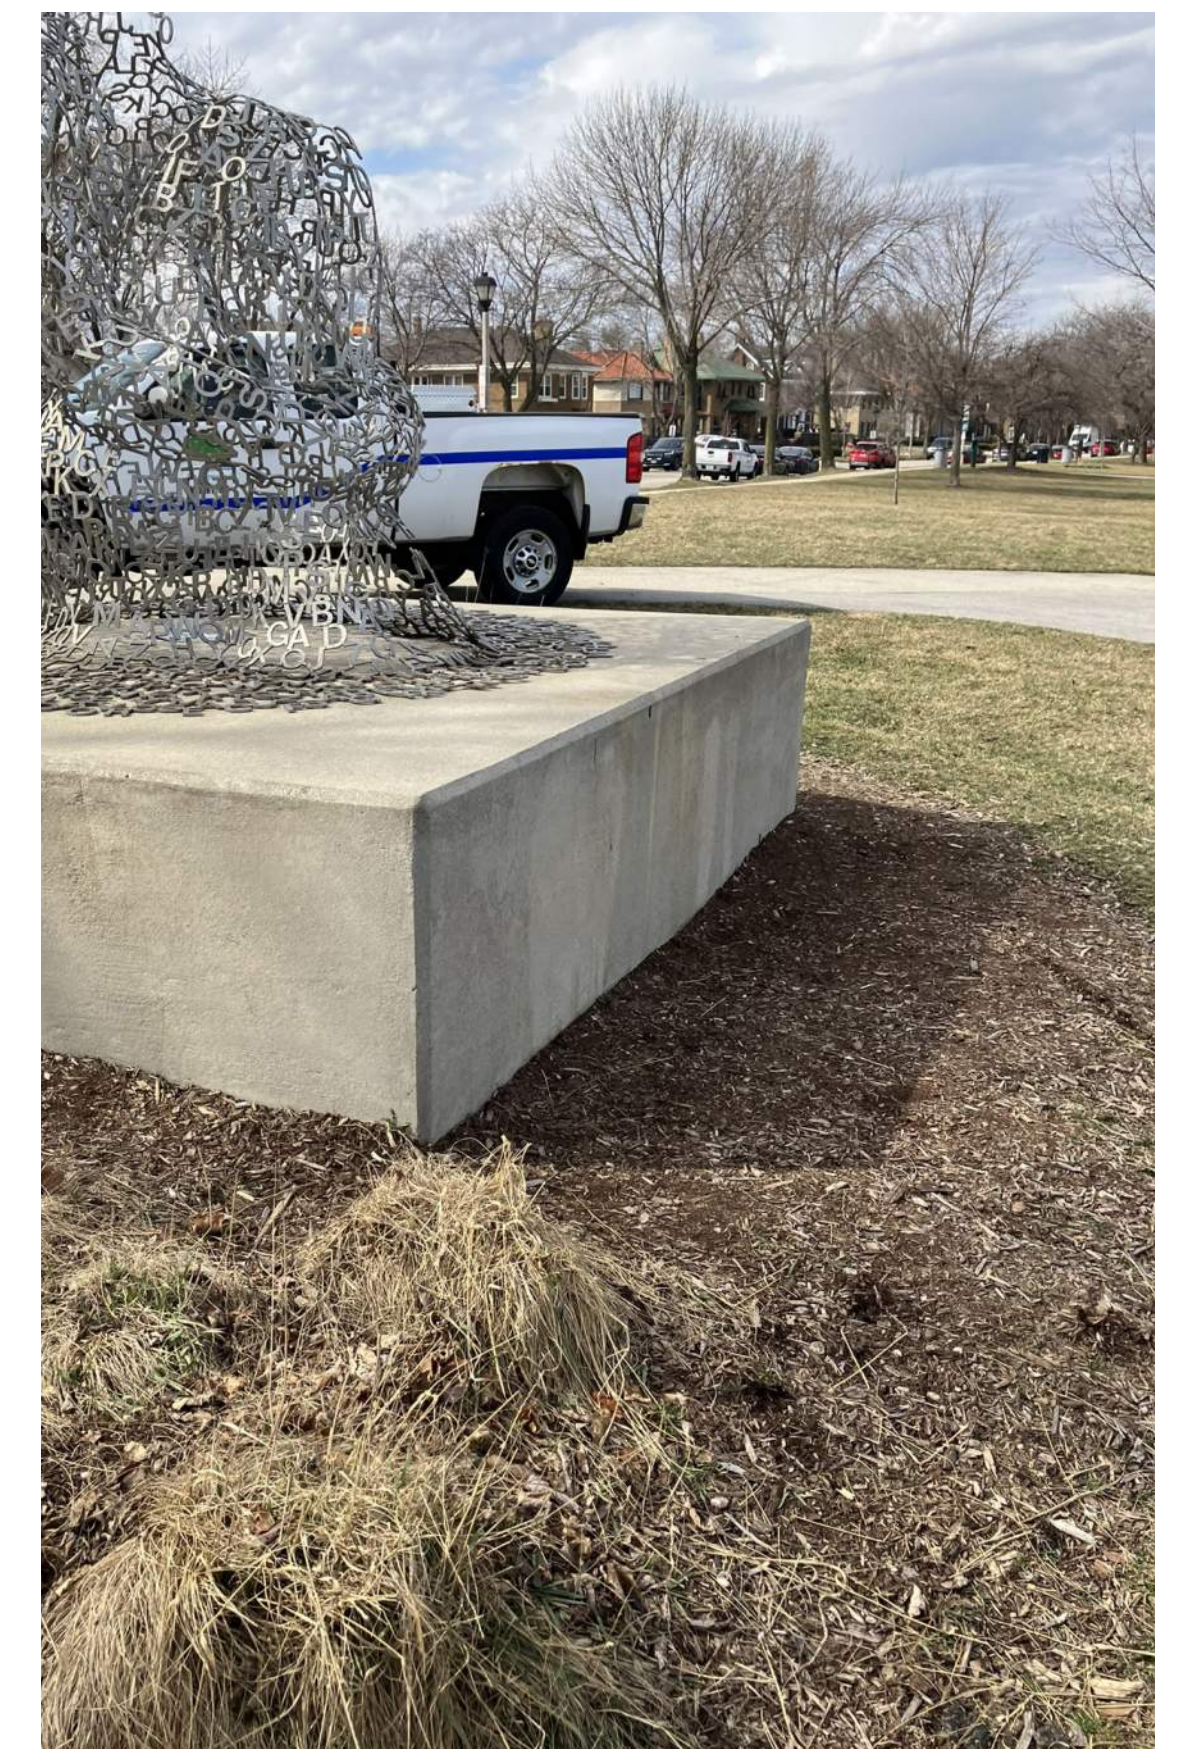
MAINTENANCE VEHICLE AREAS:

- Steep topography and limited turning movements creates continued maintenance challenges.
