Report for Village of Shorewood, Wisconsin

Street Lighting System Replacement Plan

April 2023

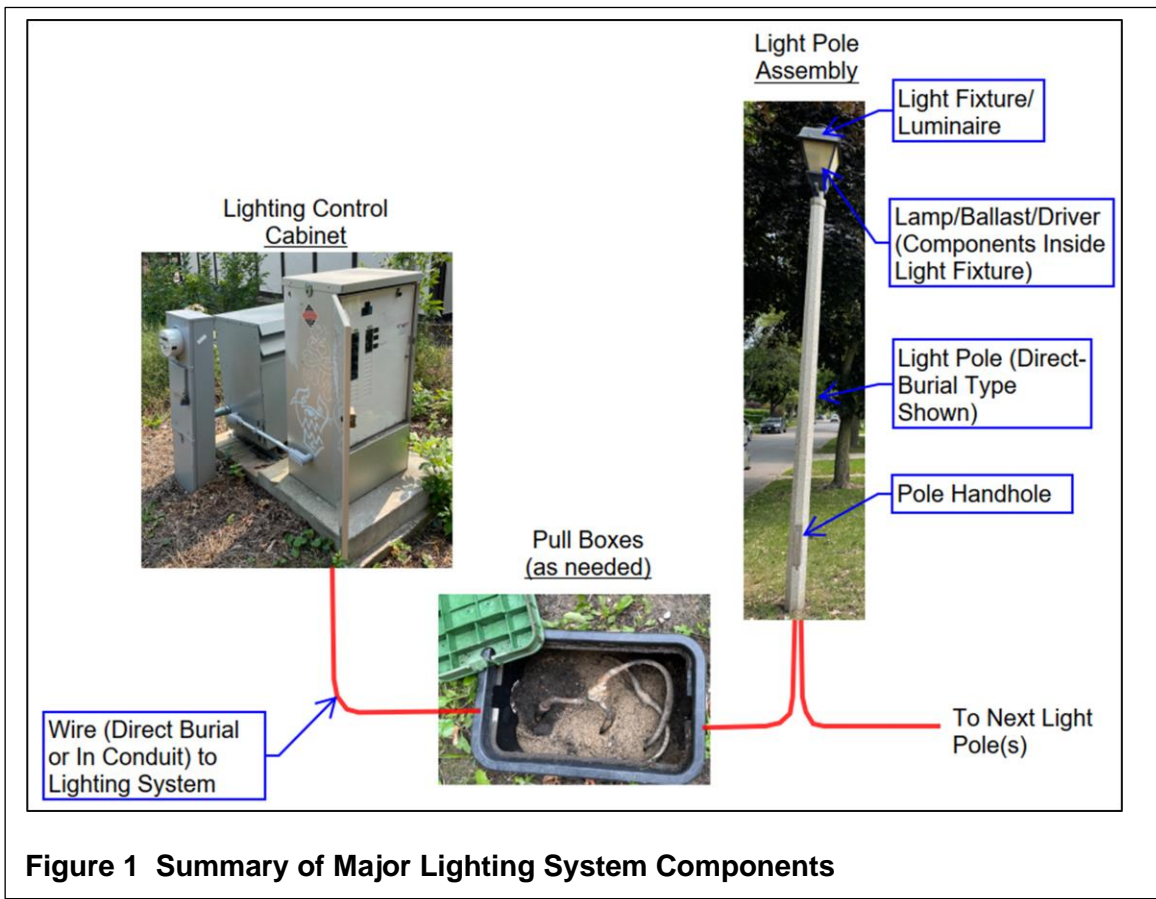
Figure 1 Summary of Major Lighting System Components

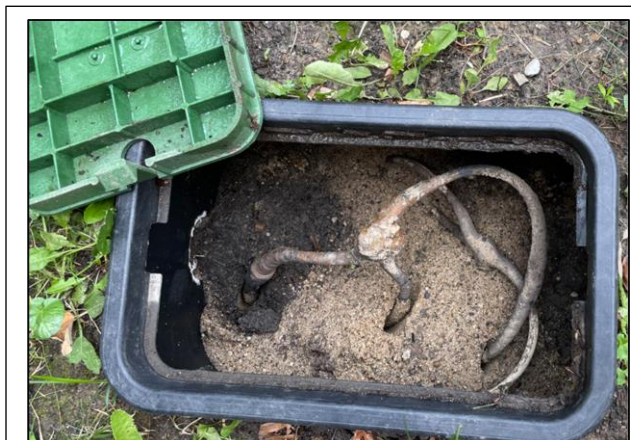
5. **Pull Boxes Are Not Code-Compliant**—Some of the electrical pull boxes within the Village that have been replaced since the 1970s installation do not meet NEC requirements for pull boxes (see Figure 2). Specifically, they are not identified as “Electrical” on the pull box covers and the covers can be opened without using any tools. This means that the public could have access to 480-V wires, which poses a safety hazard.

Figure 2 Some Existing Pull Boxes Do Not Require Tools to Access 480-V Wiring

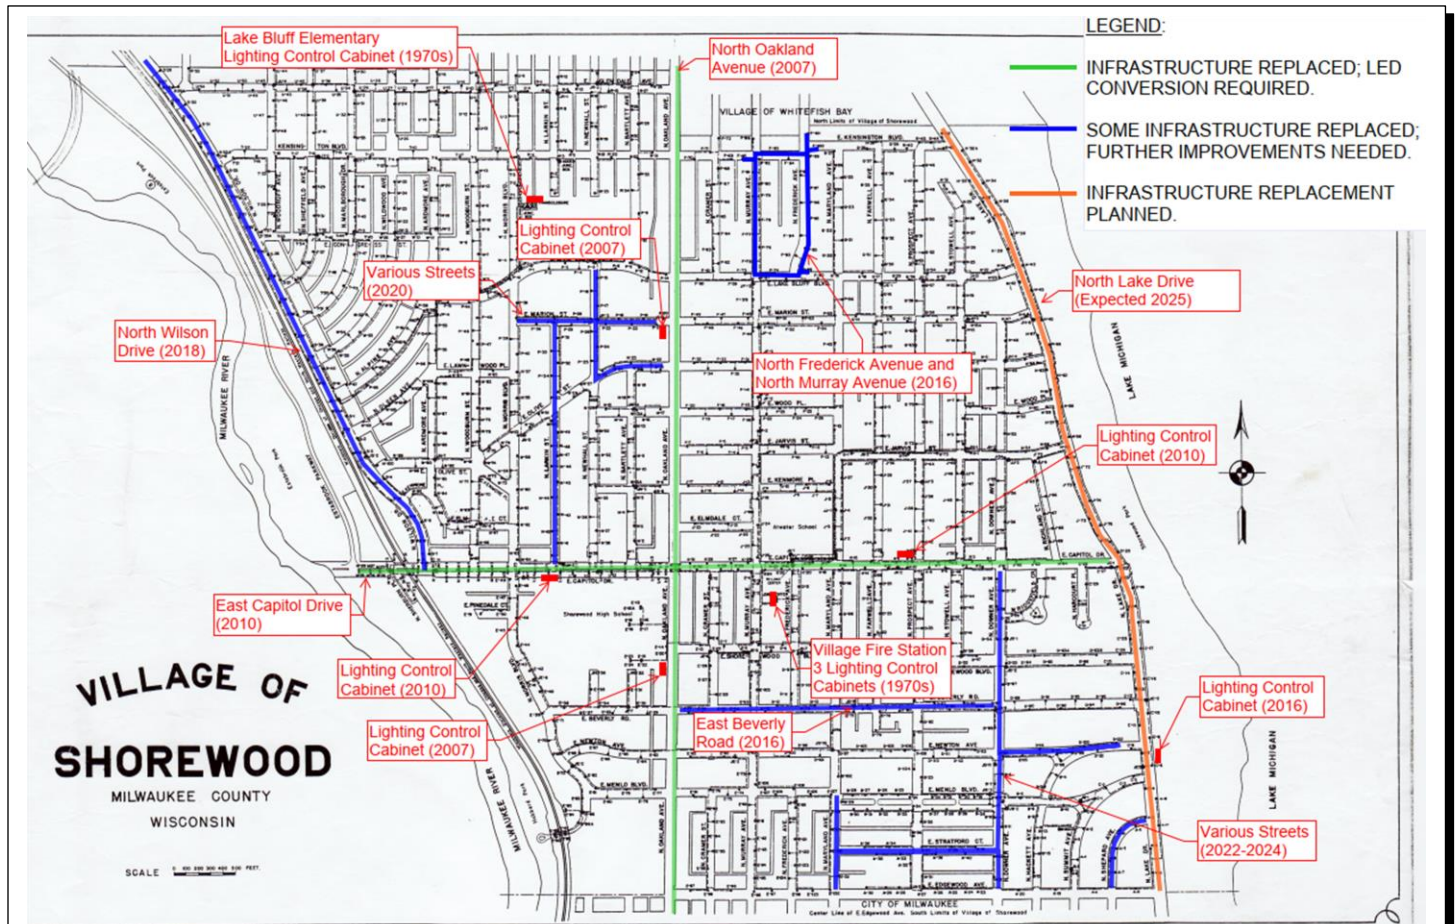
Figure 3 Summary of Completed and Planned Street Lighting System Improvements Since 1970s Installation

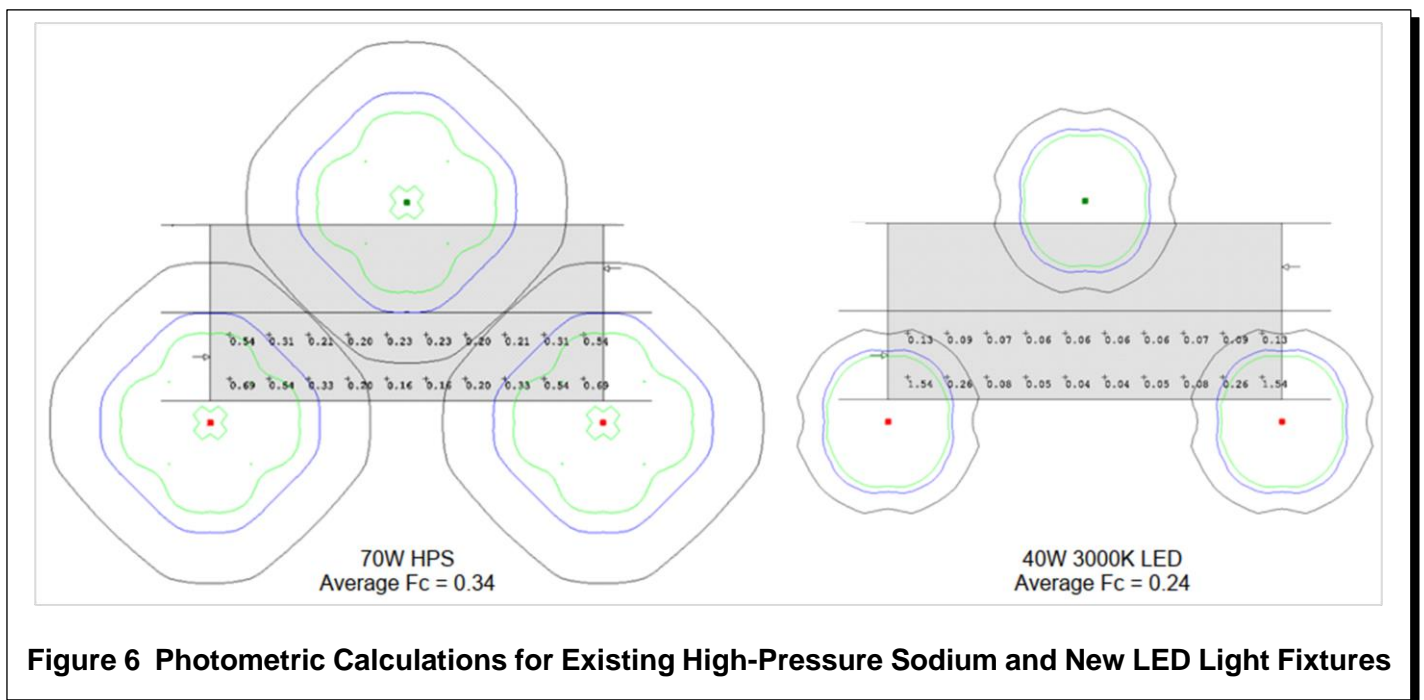
- e. Lens Type—Refractive Lens Panels. The refractive lens used in the analysis appears to lead to poor lighting distribution, but was selected to match existing light fixtures. This selection should be reviewed further during a future design phase.

Figure 6 Photometric Calculations for Existing High-Pressure Sodium and New LED Light Fixtures

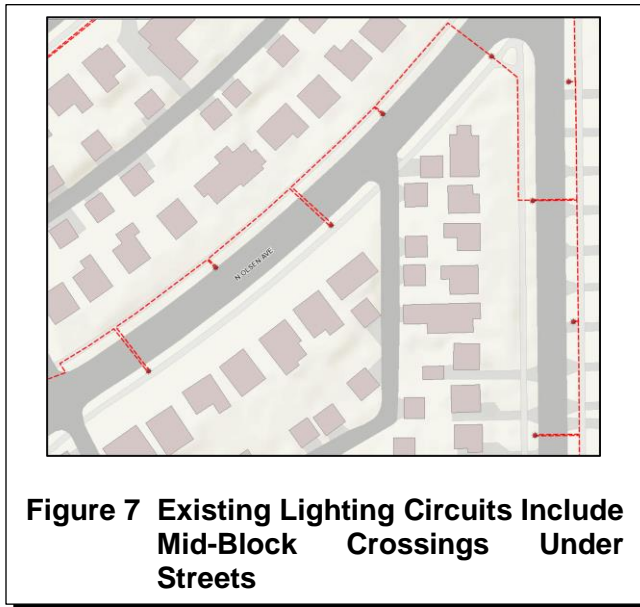
- ii. The existing lighting system wiring is configured to include numerous mid-block crossing under streets as shown in Figure 7, which is not ideal

for roadway construction activities (increases chances of accidental lighting circuit interruption) or wiring maintenance and repair activities. In recent projects involving lighting circuit wire replacement, Village staff have opted to modify the circuit routes so that new wire and conduit street crossing locations are limited to intersections and then routed along both sides of the street to eliminate mid-block street crossings where possible. This change would lead to an increase of about 35 percent in the overall wire and conduit lengths based on a review of a few existing circuits. The wire and conduit lengths used for the budgetary OPC were increased by 35 percent to account for these improvements.
